A Comparison of Reclaimed  
Strip Mine Soils Under  
Old and New Laws in Ohio

March 1974

Soil samples from three mining areas, two reclaimed under old law and one under the new law, were collected and analyzed in order to evaluate the effectiveness of new law regulations.

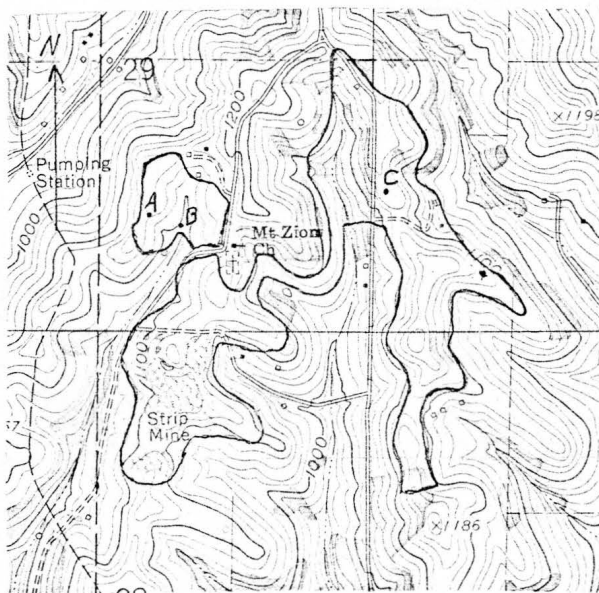
Figure 1: Map of area A from Quaker City Quadrangle.

In this area reclamation was completed under the old laws, consequently , no topsoil was replaced. Forty soil samples and three water samples were taken from throughout the area. The soil samples had an average pH of 3.99, a lime index of 46, high available phosphorous, and low exchangeable potassium. Site A was a low spot on the spoil, which was filled with water. The water had a pH of 2.35 and an iron content of 25.5 ppm. Site B was a small pond (figure 7) which had a pH of 2.87 and an iron content of 8.0 ppm. Site C is another low spot in the spoil that contains water throughout the year. The water had a pH of 3.05 and an iron content of 1.4 ppm.

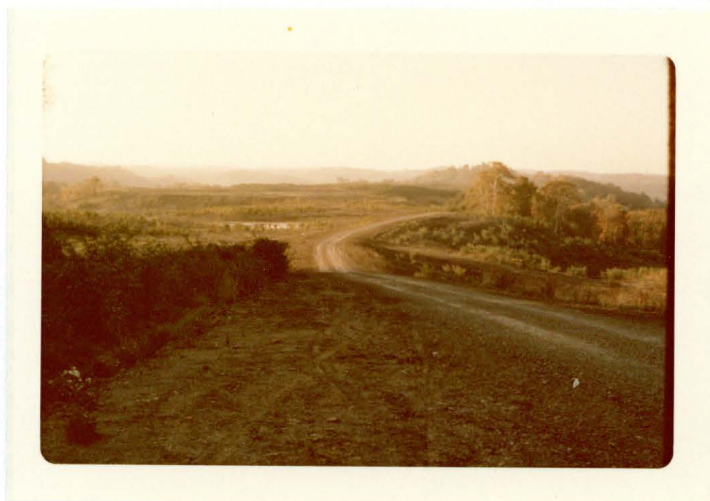
Figure 5: Small pond in a reclaimed area(site C, figure 1).

Figure 6: Different view of pond in figure 5.

Figures 5 and 6 is a small pond representing point C in figure 1. This photograph was taken one year after the area had been reclaimed under the old law. The pond is a low spot in the spoil material and therefore does not drain into any stream, but it contains water all year. This area was planted with grasses and black locus trees. As can be seen, their growth was not good. Ten soil samples were taken within the area of figure 5, and the average pH of the soil was 3.99. The pH of the water was 3.05 and the iron content was 1.40 ppm.

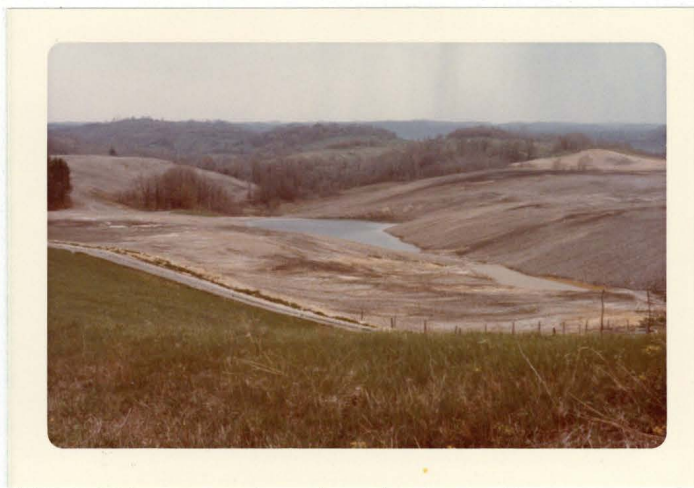
Figure 7: Small impoundment in a reclaimed area(site B, figure 1)

This photograph was taken in the area of figure 1. The pond is represented as site B, while site A is to the right of the pond, just beyond the edge of the picture. Eleven soil samples were taken from this area and the average pH of the soil was 3.5. The water in the pond had a pH of 2.87 and an iron content of 8.0 ppm. The other water sample taken in the low spot to the right of the pond had a pH of 2.35 and an iron content of 25.5 ppm.

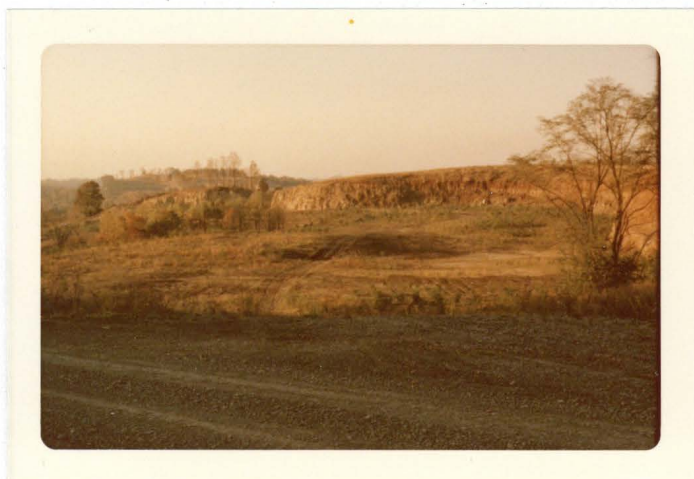
Figure 8: Area adjacent to impoundment.

This picture is of an area immediately adjacent to figure 6. The photograph was taken two years after reclamation. As can be seen in figures 6 and 8, some of the vegetation is growing, but it is very spotty and is too sparse to have much affect on erosion.

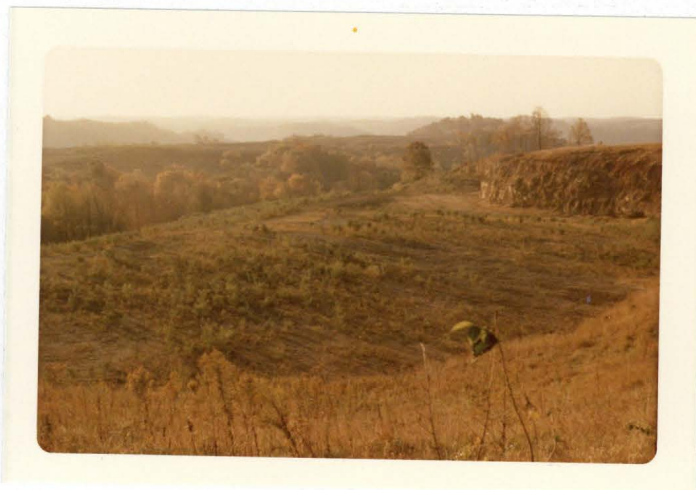
Figure 9: View of a reclaimed area.

Figure 9 represents the same area shown in figure 8, note vegetation growth and also how the spoil was merely leveled and the highwalls left unaltered.

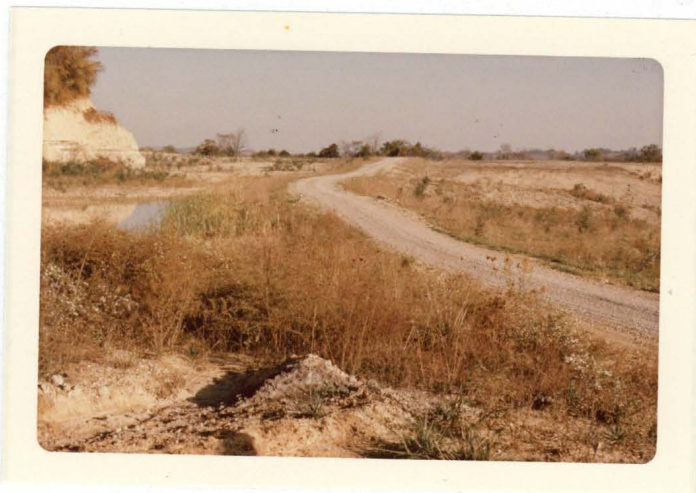
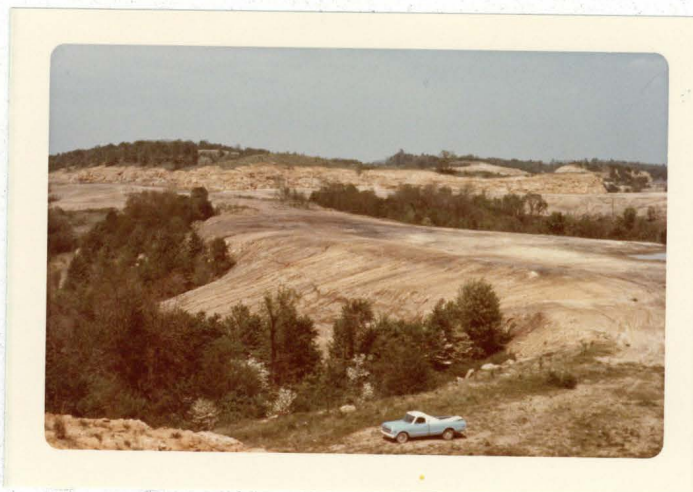
Figure 10: Area reclaimed under the old law.

Figure 11: Area reclaimed under the old law.

Figures 10 and 11 represent areas reclaimed under the old law and show that the areas were simply leveled and abandoned. The highwalls are left standing untouched and , due to the lack of any topsoil, there is no vegetation cover and therefore the area resembles a desert. The complete lack of any vegetation, as in figure 11, greatly increases the rate of erosion. The tremendous increase in the amounts of sediment carried by the streams draining these areas can cause extensive damage, as is evident in the following figures.

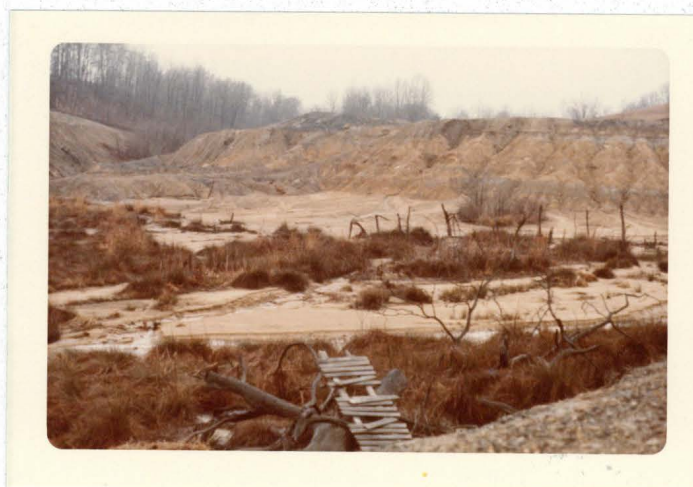
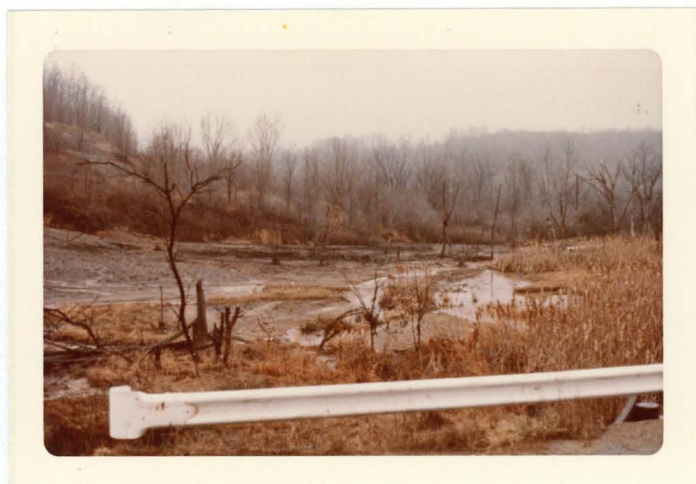
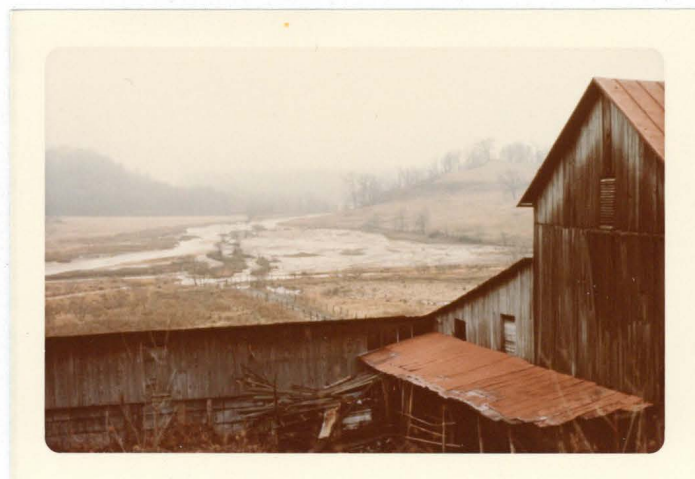
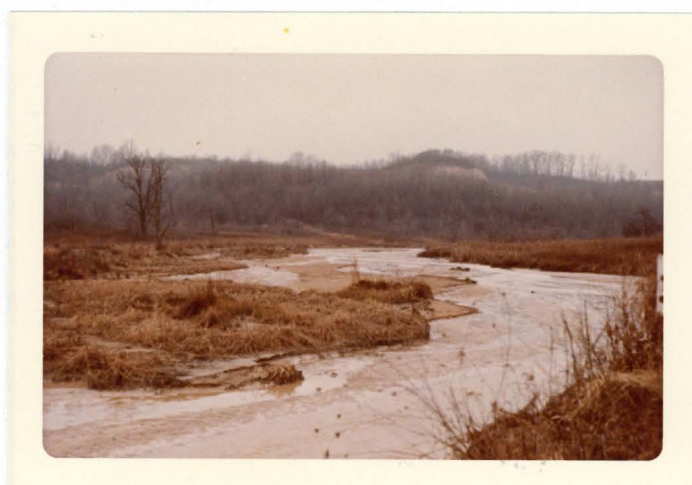
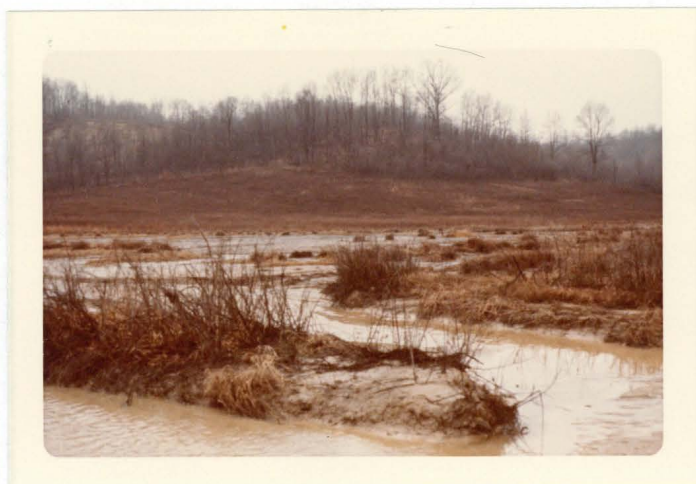
Figure 12: Damage due to siltation.

Figure 13: Damage due to siltation.

Figure 14: Damage due to siltation.

Figure 15: Damage due to siltation.

Figure 16: Damage due to siltation.

Figures 12 - 16 were taken in Meigs County, Ohio, in order to show the damage caused by siltation, which results from the lack of vegetation on old mined areas. These areas in Meigs County were mined between 10 and 20 years ago. Figure 12 is an area immediately adjacent to a spoil pile, and the sediment in the foreground was derived from the spoil material in the background. Figure 13 was taken a short distance down stream from Figure 12 and shows how the sediment affects other areas as it moves downstream. Figure 14 was taken of a different stream but in the same area. The source of the sediments was an old mine in the center background of the picture. There was a great deal of damage done here because the farm in the picture was completely divided by the stream. The stream, which was not very large, could easily be crossed to gain access to that part of the farm on the other side. After the

stream began dumping large amounts of sediment, it began to widen and now there is a strip of sand almost 200 feet wide and 10 feet deep through the middle of the farm. Not only is much of the land now covered by sand, which is not productive, but it is impossible to transport machinery across the stream, except during the driest part of the year. The land owner had at the time of the actual mining in the area, refused to sell any of his land for mining purposes. However his neighbors upstream did, and the result was extensive damage to his farm. He could do nothing about these effects because of the weak mining laws of the time, and the company that strip-ped the land is now out of business. Figures 15 and 16 were taken of the same stream that is shown in figure 14, only farther downstream in order to show the continuous streamside damage.

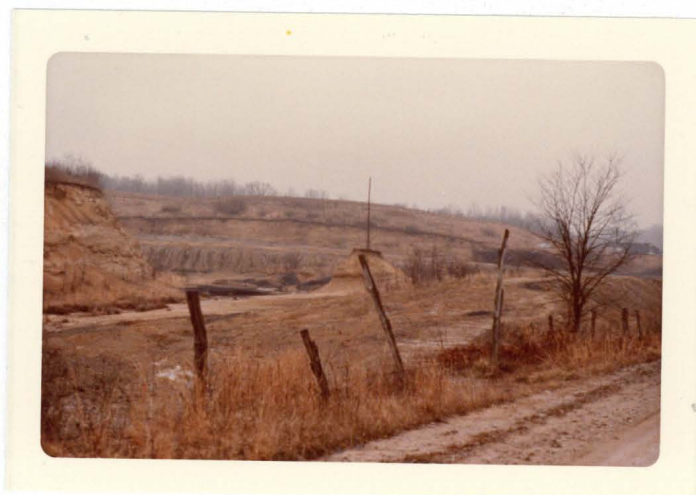
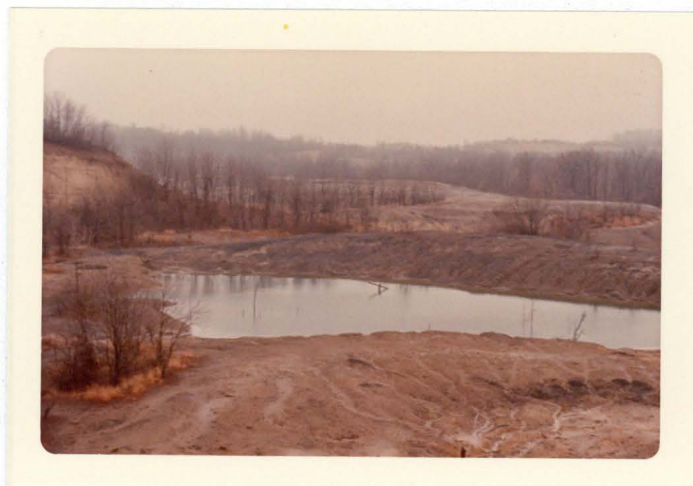
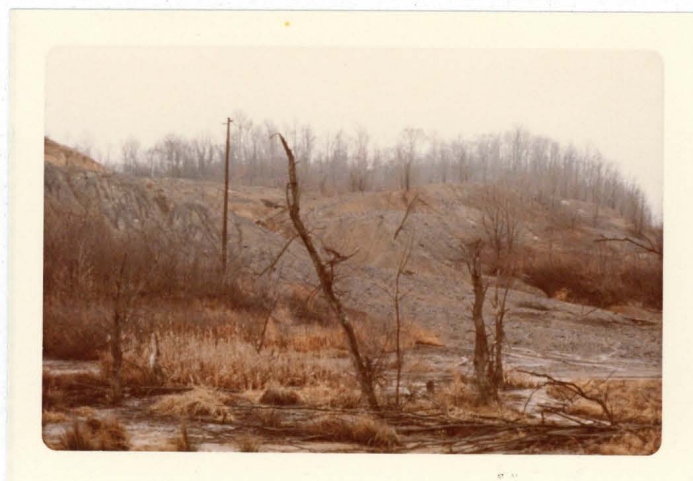
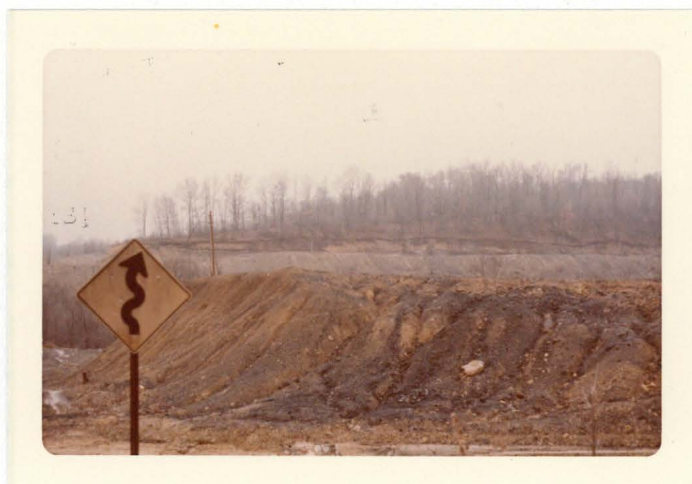
Figure 17: Area exhibiting scenic value of old law strip mines.

Figure 18: Area exhibiting scenic value of old law strip mines.

Figure 19: Figure exhibiting scenic value of old law strip mines.

Figure 20: Area exhibiting scenic value of old law strip mines.

Figures 17, 18, 19, and 20 were also taken in Meigs County, mainly to show the unsightliness of old mines. These areas were simply stripped and abandoned. They are completely barren, there is no vegetation even after 20 years, except around the edges of the mine where the topsoil was not disturbed. Mines such as these cause the major problems associated with mine pollution-- the acid drainage and siltation of streams.

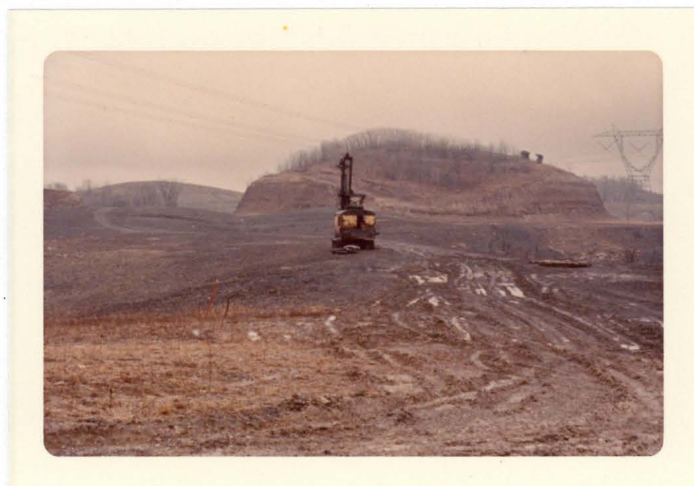
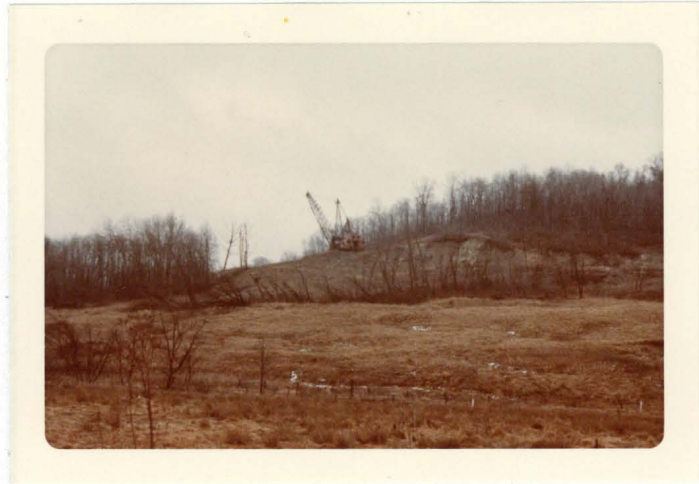
Figure 21: Abandon shovel in area in figure 1.

Figure 22: Abandon dragline in area in figure 1.

Figures 21 and 22 were taken in Noble County, Ohio to show other problems associated with mining. Many mining companies leave behind piles of old scrap metal, and as can be seen here, old machinery. Figure 21 is an old abandoned shovel that at one time was used to remove overburden and to load coal. Because of its small size and its age, it was not economical to keep it in repair and use. Figure 22 is of a dragline of considerably larger size than the shovel in figure 21, but it too is small by today's standards of machinery, and due to this and its age, it was left setting with its boom erect and cables still intact. Scenes like this are no longer allowed, because under the new law, mining companies are required to remove or bury any old machinery, scrap metal, or old buildings used during the operation.

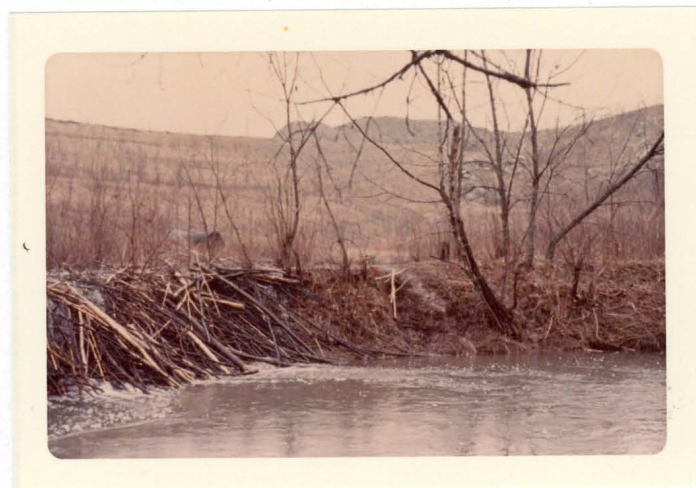
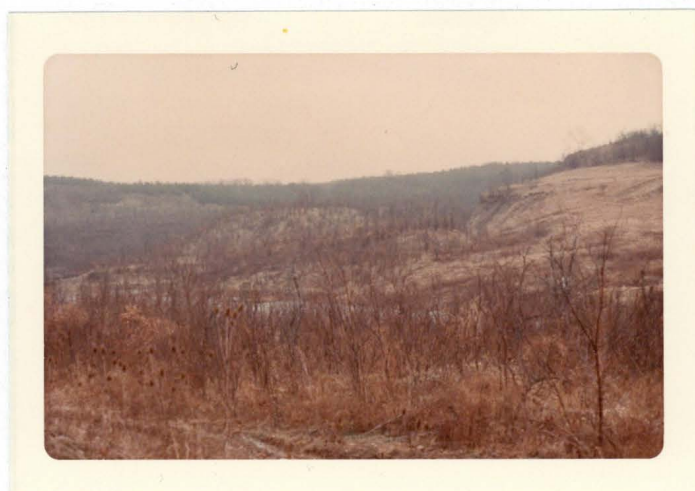
Figure 23: Area reclaimed under old law.

Figure 24: Area reclaimed under old law.

Figures 23 and 24 were taken in Muskingum County, Ohio to show that not all mines reclaimed under the old law are bad. Even under the old law some companies took it upon themselves to properly reclaim mines so they would not become waste land. These two areas were mined and reclaimed by the Ohio Power Company, and can hardly be recognized as ever having been strip mines.

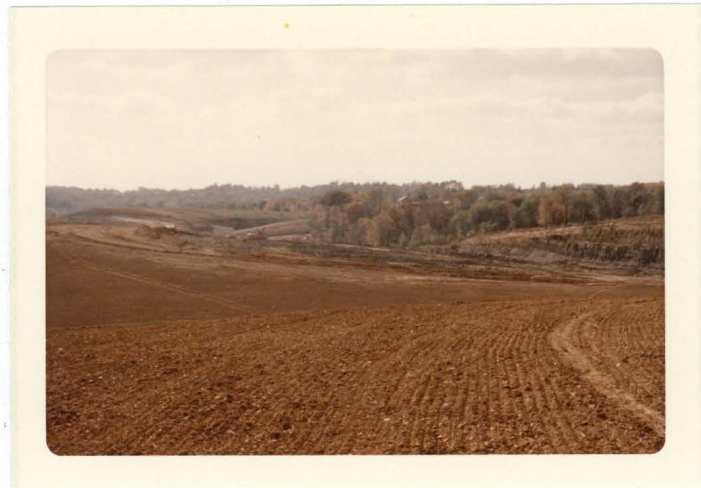
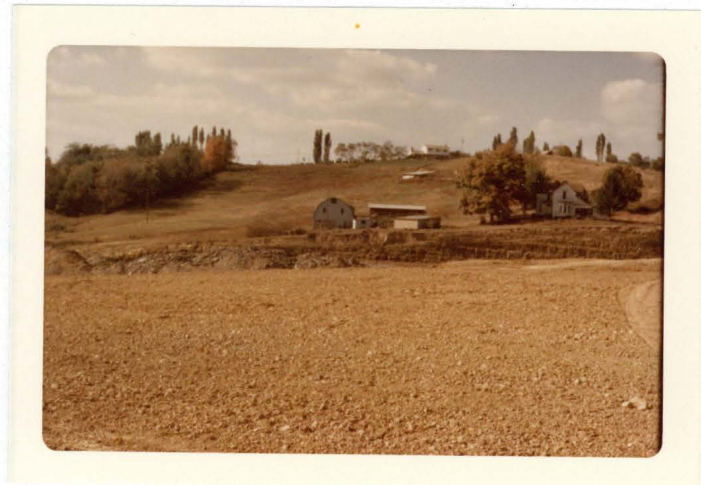
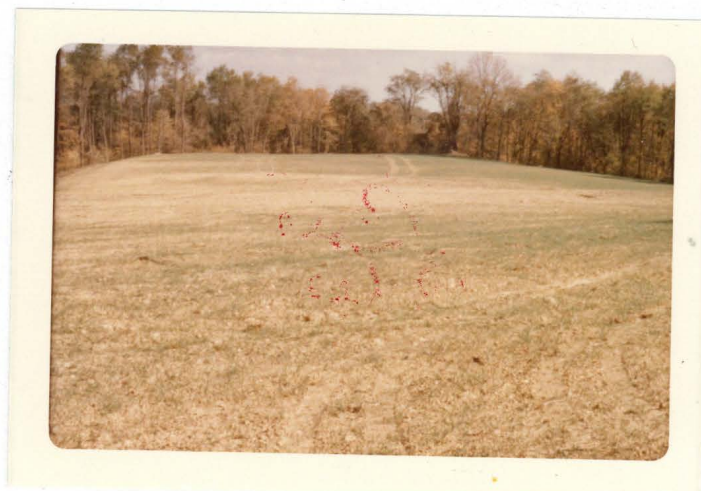
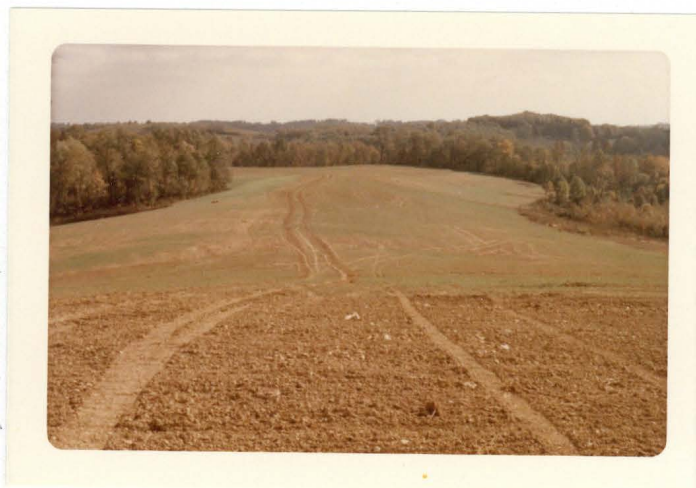
Figure 25: Strip mine under new law.

Figure 26: Strip mine under new law.

Figure 27: Strip mine under new law.

Figure 28: Strip mine under new law.

Figures 25 - 26 were taken in Belmont County, Ohio. This area was mined and reclaimed under the new law. The water draining this area had an average pH of 6.55 and an iron content of 0.035 ppm. In figure 25 and figure 26 it can be seen how close the active pit is to reclaimed land. The reclamation follows very close to the mining- only about 200 yards between the highwalls and the reclaimed area are left open. This prevents almost all acid drainage which results from having open pits left for long periods of time. Figures 27 and 28 show the land after being reclaimed, it is in sharp contrast to pits under the old law. No highwalls are present, the area has the same topography as before and due to the replaced topsoil, vegetation is extremely good and uniform.
